## 2015 LEXUS NX NX300H F SPORT 4WD

### VEHICLE DETAILS

# CONDITION SHEET & PHOTOS

# CONDITION SHEET ENGLISH TRANSLATION

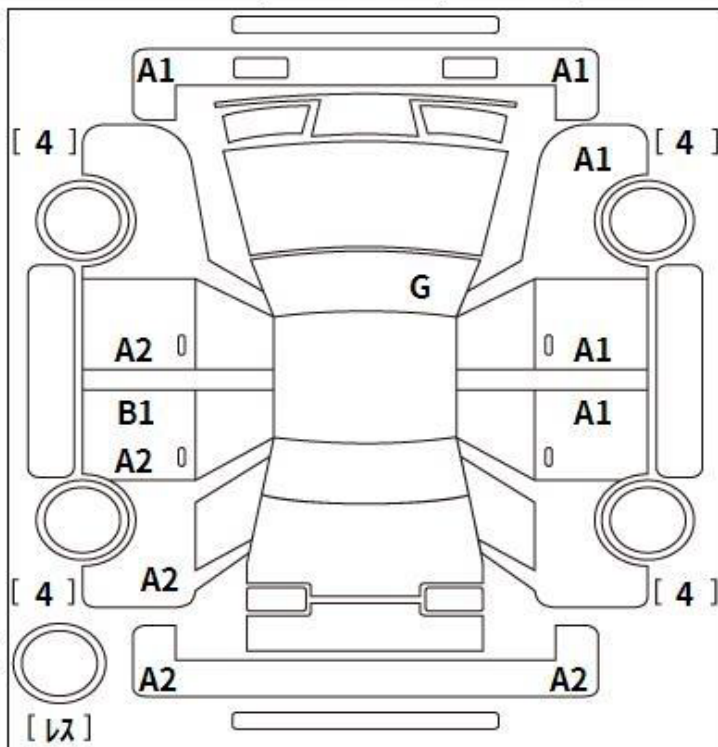
検査員記入欄
外装うすい線キズ シートしわ 室内内張傷 下廻りS小
事務局よりご案内
キーロック

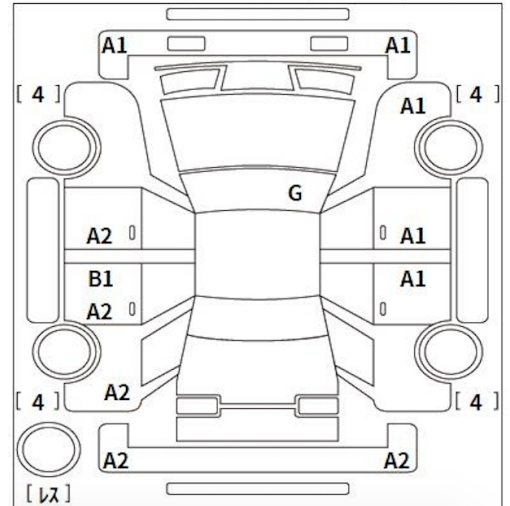
- Thin line scratches exterior
- Seat wrinkles
- Indoor lining damages/wound
- Underbody small rust
