1997 NISSAN 180SX TYPE X TURBO (Sample Preview)

Report created by hand on 2021-06-25

CONDITION SHEETS & PHOTOS

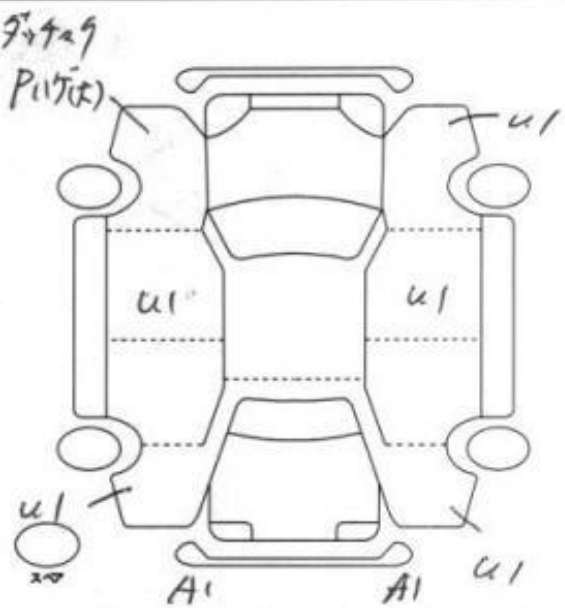
Date : 2019- - 2019- Source : JU Ibaraki Lot No :

出品番号	初度登録年月	車名・グレード	2WD 4WD	評価点
	9 5月	180SX 4X4X7-ボ		R <small>小</small>
型式	排気量	ドア	定員	ディーラー・並行人
E-RPS13	2000 CC	形状	積載	モデル年式
				kg
				ハンドル 左・右
車歴	シフト	セールスポイント (正常に機能するものに限ります)		
自家用・()	F5	H9年5月27日		
車検	冷房	SR207-ボ		
2-31年 5月(日)	AA	5本!!		
走行	燃料	装備品 (純正品に限り○をつけてください)		
193 km	ガソリン 軽油	PS SR	PW ナビ	ABS TV
色	色替	AW	エアド	AW
326	326		本革	
R券	名変期限	新車保証書		
1060 円	月 日	有・無		
注意事項申告欄 (不具合内容等は具体的に記入して下さい)				
修復歴 有 (箇所)				
検査員	FW	キズ・飛石・ヒビ割・リペア跡・×要		
記入欄	内装	キズ・汚損・コゲ・穴・破		
<p>左F110キ、15.7u歪</p> <p>112ドW2L(大)</p> <p>シート2L</p> <p>キズ、ヒ、W2 24キ</p> <p>ウミラ-カ11-キズ</p> <p>AWキズ</p> <p>下廻4キ</p>				
車台番号	326348			
登録番号				
型式指定番号	車庫証明用	長さ	幅	高さ
		cm	cm	cm

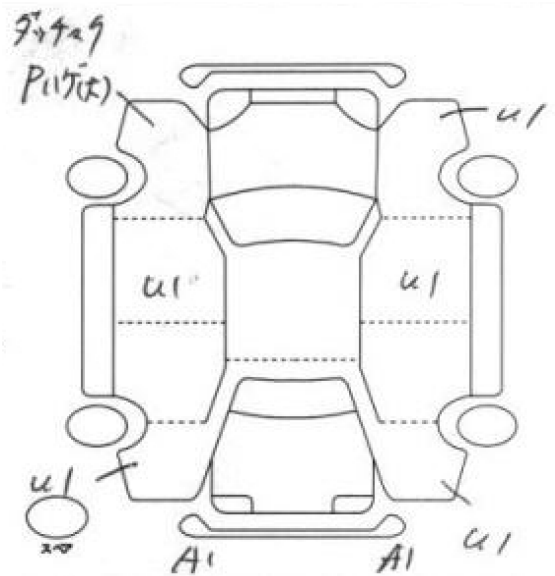
Date : 2019-█ - 2019-█ Source : JU Ibaraki Lot No : █

Some exterior scratches and dents
 Left instrument panel - panel distortion
 Steering wheel significantly scuffed
 Door mirror scratch, Dirty cabin
 Seat scuffs
 Wheels - scratches
 Underbody - rust

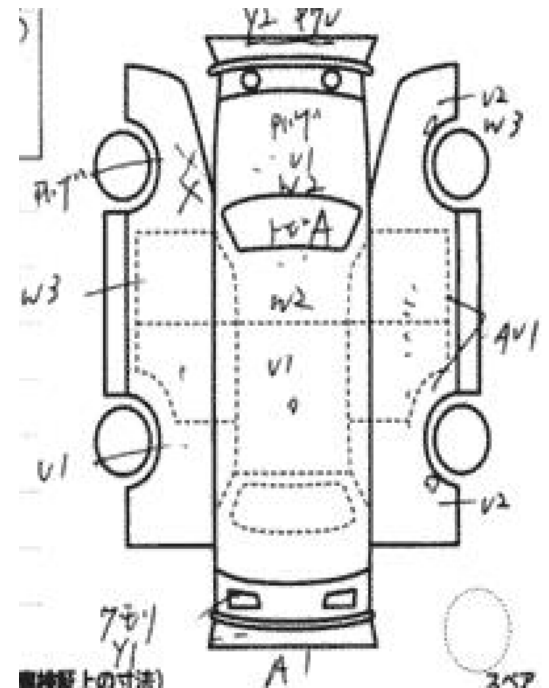
Date : 2019- Source : USS Tokyo Lot No :

- Front side - repair
- Steering wheel - cut, significant scuffs.
- Cabin - dirty, scuffs, Cabin trim - sagging
- Air conditioner - does not cool well
- Non original wheels - corrosion
- Oil bleeding, Under body - rust
- Front panels - partually bends
- Doors` mirrors - scratches, paint fading
- Left baffle and front inner panel - bends
- Body - scratches, dents, repair
- Left front fender - paint peeling
- Right front fender, roof - repair marks
- Windscreen - chips, scathces
- Front bumper - cracks on paint, cracks
- Bonnet - paint peeling, repair marks
- Left tail lamp - clouded, cracks
