**1994 TOYOTA CELICA GT-FOUR**

Report created by hand on 2021-07-05

CONDITION SHEET & PHOTOS

# CONDITION SHEET ENGLISH TRANSLATION

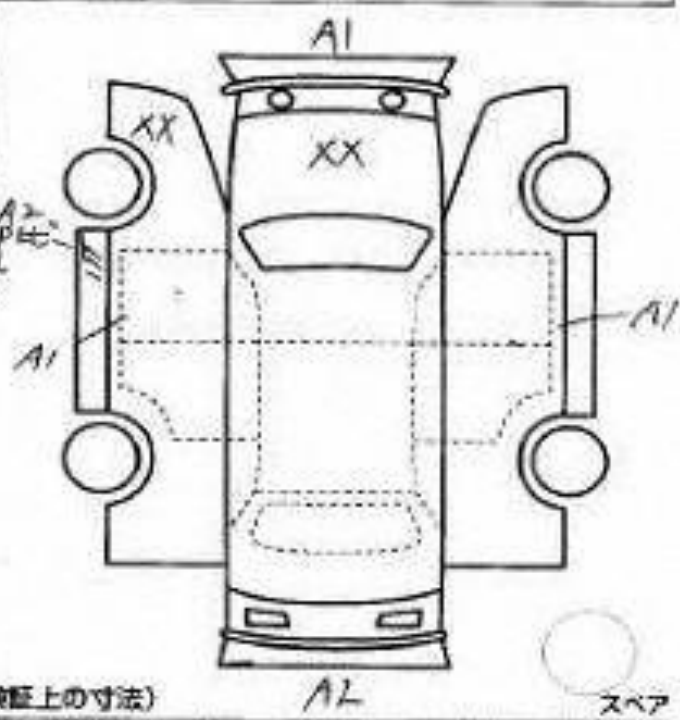
- ★社外ステアリング 大7インチ
- ★社外17インチAW
- ★色替車 黒→ワイン
- F修理厂

- ドアトリムハガレ 左下内ハガレ
- ルーフ内コブ
- シート色TE
- 外装各所PIG(内)
- ホイールセンターCP欠
- 外エッジ
- Rゲートパネ不良

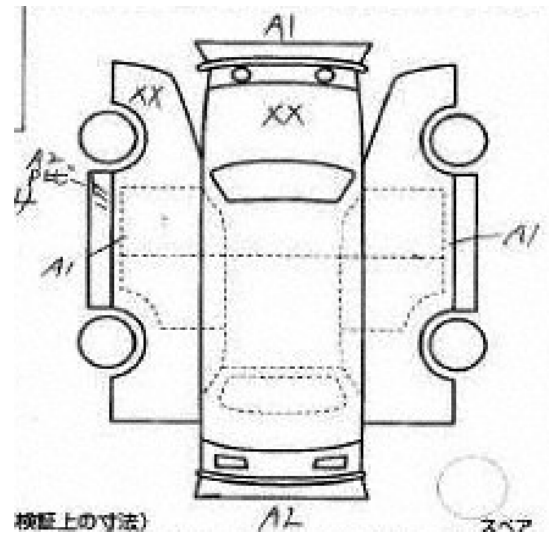
Left front inner panel edge, baffler -deformations  
 Some exterior scratches and dents  
 Hood, left front fender were replaced **XX**  
 Stripped door trim  
 Dirty cabin  
 Faded seats  
 Badly peeled paint on the body  
 Lack of wheel hubcaps  
 Non original air cleaner  
 Rear gate damper - not working  
 Overheat marks  
 Rust in radiator
