# 1993 TOYOTA MR2 GT

Report created by hand on 2021-05-20

CONDITION SHEET & PHOTOS

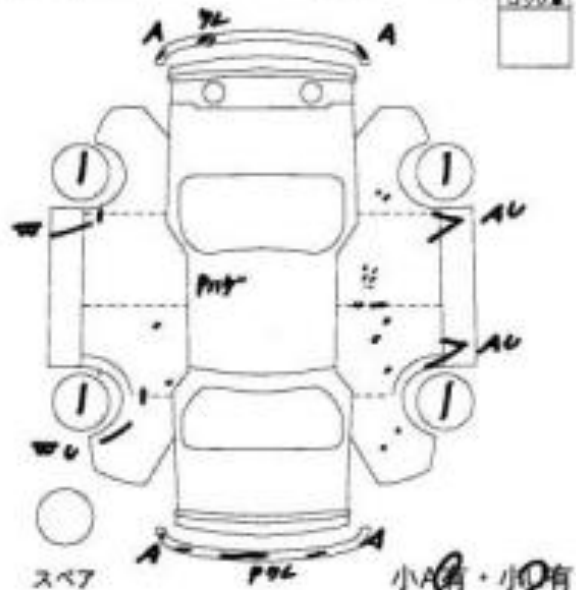
出品番号	初度登録年月	車名	ドア	形状	グレード	評価点
	5年 月	MR2	2	CP	GT	3.5
車種	車体	型式	排気量	定員		
乗用車	( )	E-SW20	2000cc	2人		
車検	年月日	フロア	AT	セルシースポイント	レカロシート MOMOハンドル	
走行	十 万 千 百 十 一	コラム	MTのみ 5速		[外装]	B
	515 km (試乗)	ダッシュ			[内装]	B
外装色	了オ	冷房	AAC		純正品のみ 丸印	
内装色	ク	燃料	ガソリン軽油	PS (ワックス)	PW (ブレーキ)	AW (エンジンオイル)
	8J2	輸入車		カワ (ワッシャー)	AB (エアバッグ)	TV (オーディオ)
新車保証書	取扱説明書	R券 ¥	9,070	SR (サンルーフ)	ナビ	
注意事項	後日品【 不具合箇所等	名変期限	月 日迄			
検査員記入	ガラス	④・X要ス	シート	④・コゲ・穴・汚れ・破れ	車台No. SW20- [ ]	
シートキャブレ・ホイールA						
R2ホ・A. P/Sランプ点灯						
トランク内張り欠						
長さ	幅	高さ	種数	kg

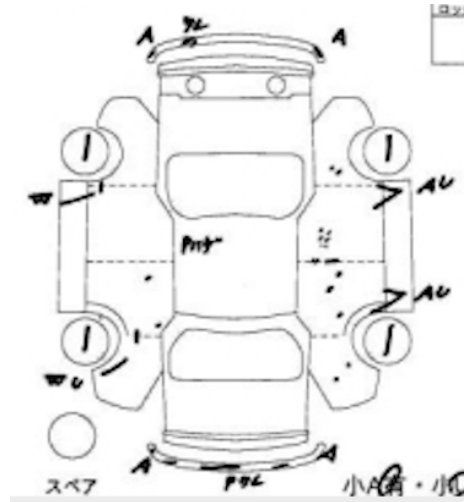
- Scratches on exterior **A**
- Seat scuffs
- Wheel scratches
- Rear spoiler scratches
- P/S Lamp lit
- Trunk floor scratches, dents

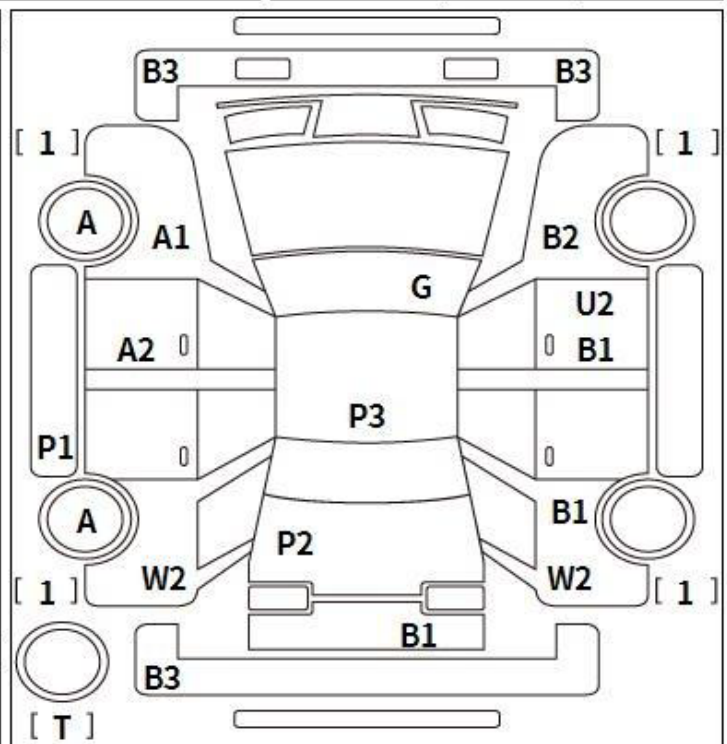
注意事項欄	車台番号
PSランプ点灯、社外ハンドル	SW20-
	諸元
	長さ 幅 高さ

検査員記入欄
トランクフロア小U 足廻り異音 エンジン廻りオイル漏れ ダッシュ板歪み・うき大 シート切れ・破れ大 シート汚れ 荷室内張欠品 タッチP跡 社外シフトノブ 社外ステレオ シフトブーツ破れ ブースト計不良 社外ブローオフバルブ取付
事務局よりご案内

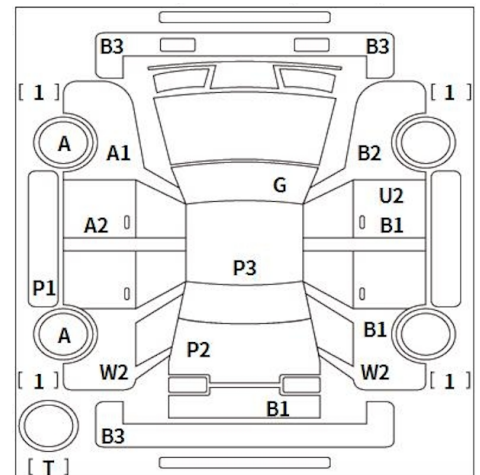
- Trunk floor small dents
- Noise around undercarriage suspension
- Oil leakage around the engine
- Dashboard large distortion
- Seat torn, cut, large
- Seat dirt
- Luggage compartment lining missing
- Touch up paint traces
- Aftermarket Shift knob
- Aftermarket Stereo
- Shift boot torn
- booster failure
- Aftermarket blow-off valve installation
