2009 AUDI S3 SPORTBACK 2.0 QUATTRO

Report generated on XX-XX-2020

CONDITION CHECK SHEET ENGLISH TRANSLATION

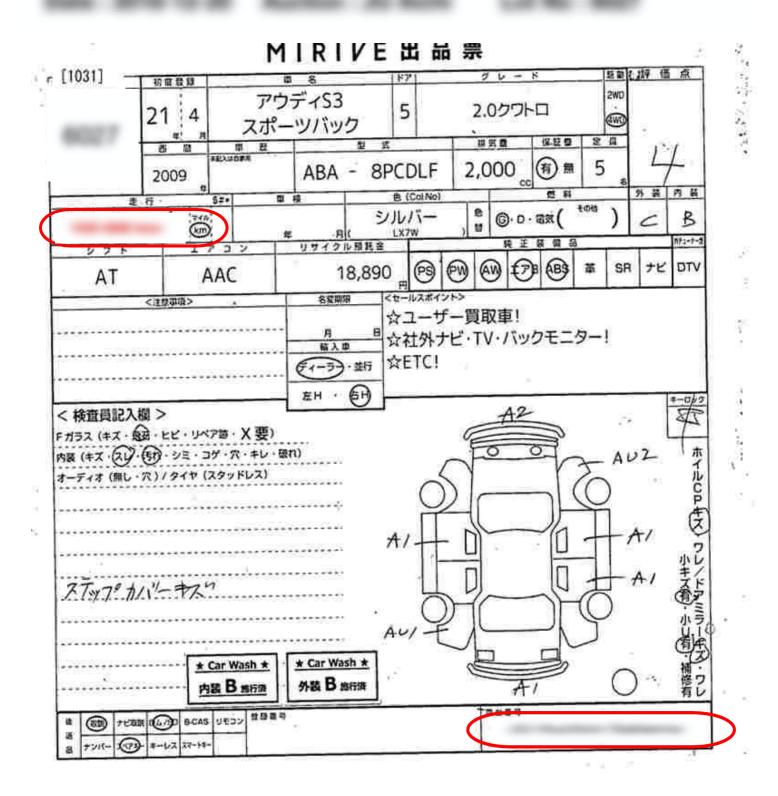
F Glass small crack Interior small scratches & stain

Small scraches on exterior A1-A2
Frontn & Rear bumper scratch

Exterior very clean Interior very clean
