1990 HONDA NSX (SAMPLE)

Report generated on 2020-04-15

CONDITION SHEET & PHOTOS

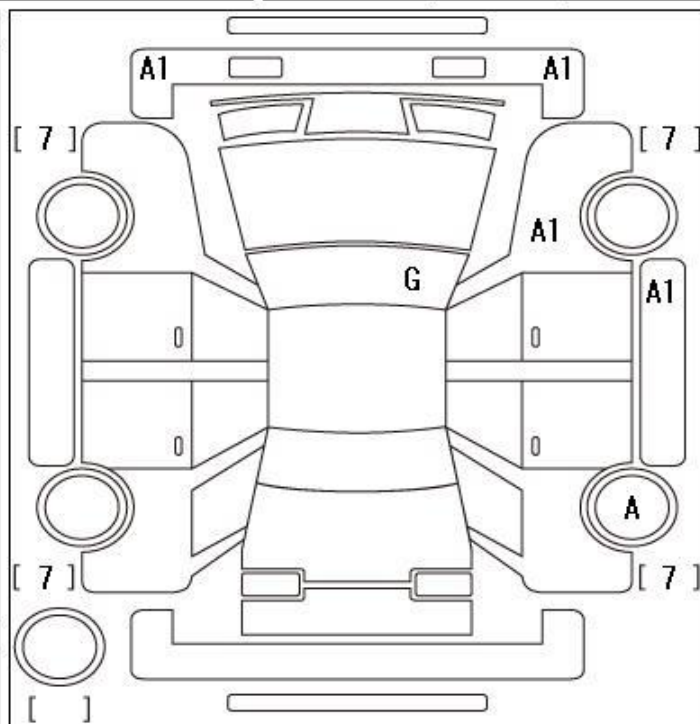
検査員記入欄
ロアサポート歪み 室内薄汚れ シートすれ小 エンドパネルU1 下廻りAU 同色全P 外装小傷有り トランクダンパー不良
事務局よりご案内
キーロック

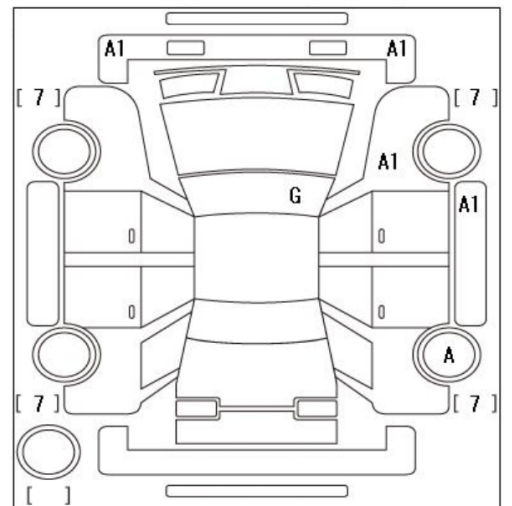
Lower support distrotron
Dirt in the Interior
Small dents on seats
Side end panels U1
Lower panel AU
Paint marks P
Small scratches on exterior
Bad trunk dumper
