2019 MERCEDES BENZ E CLASS E450 (SAMPLE)

Report generated on 10/06/2020

GRADE 5 AUTOCHECK GRADING

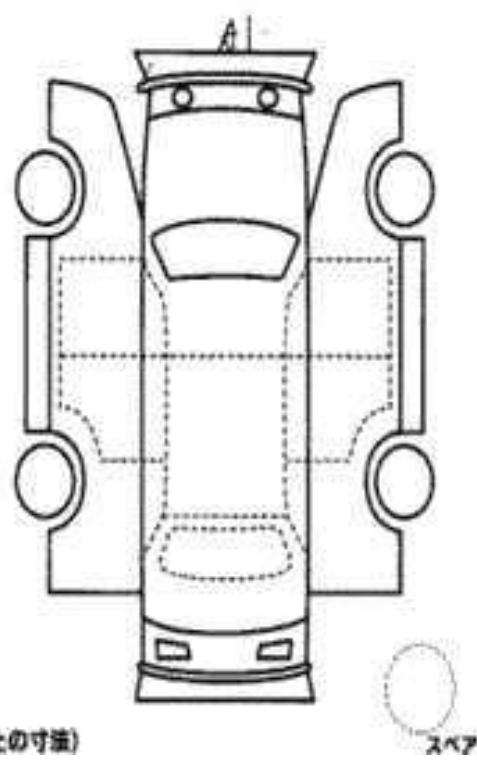
No.	車歴 (自家用以外は記入)	排気量	型式	評価点
		3000	DBA-238368	
	初年度登録年月	車名	駆動方式	内装 補助席
	3/1月	ベンツ	2WD E450 4駆 7-10	A
車検	R4年 1月	シフト	調整	
		CAT	<input checked="" type="checkbox"/> 調整 <input checked="" type="checkbox"/> 油圧	
走行	マイル	冷房	セールスポイント	
		AAC	★AMGスタイリング、パラメルフ	
外色	元色	台盤	カラー	★ヘッドアップD、パワートランク
	オパール		197	★ベンチレーター、ブルメスター
燃料	ガソリン	駆動	内装	★取扱説明書、スキー、7人オーナー
			70	
輸入年所	輸入区分	ハンドル	名義変更期間	
	アメリカ	左	月 日	
リサイクル 料金は	17,700円	乗車定員	4人	登録No.
				2重 3011110750
◎注意事項 (修復・不具合箇所および状態等)				車台No.
				シリアルNo.

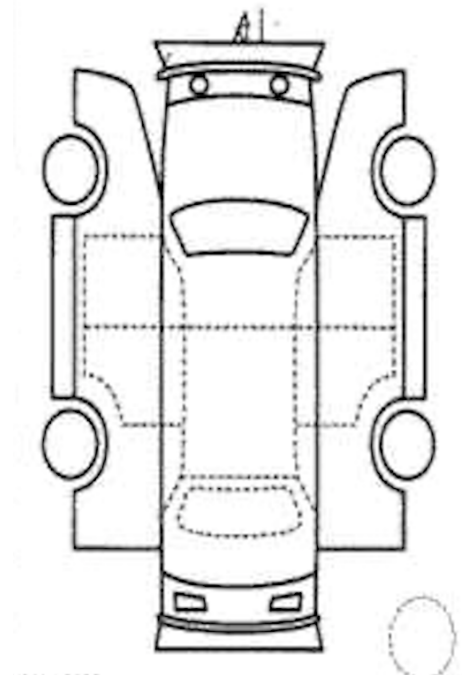
Current Inspection (Year/month)			Transmission		sunroof	alloy wheel	power steering	power window
2022/01			CAT		SW	A W	P S	P W
Mileage			Air condition		ABS	TV	Nav	Airbag
			AAC		ABS	TV	NAV	A B
original color	change color	color no:	Recycling Deposite		Sales point			
Black		197	17,700		* AMG styling * Power trunk * BURMESTER Audio * Smart key - One owner			
Fuel		Interior color	Registration number					
Petrol		Black						
Seats	Drive type	Drive	Chassis number					
4	4WD	LHD						
Notice

Inspector Report
