REPORT NO: BCNR33-XXXXXX

1995 NISSAN SKYLINE GT-R (SAMPLE)

Report generated on 2020-04-04

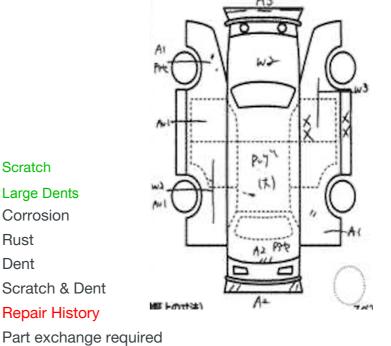
Small scratches on the Sheets

Front buffer A3

Hood repair mark W2

- Roof paint mark
- Right door replaced XX
- Right skirting replaced XX
- Fron right side repair mark W3
- Rear left side paint mark
- Scratches on the exterior A1

Rear buffer A2
