1998 PORSCHE 911 TURBO (SAMPLE)

Report generated on 2020-XX-XX

CONDITION SHEET & PHOTOS

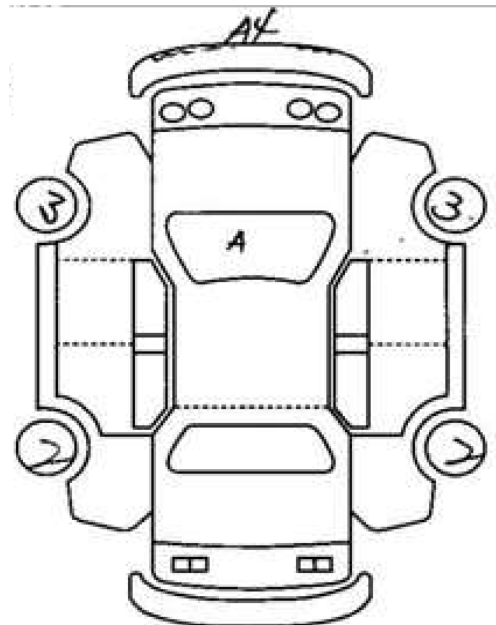
Front frame part exchange history **XX**
 Front Instrument panel **BP**
 Front side member **BP**
 Front panel part exchange history **XX**
 Small scratches on exterior **A-U**
 Oil leak
 Muffler restoration
 Clutch replacement
 Entrnal shift knob
