2003 SUBARU IMPREZA WRX STI (SAMPLE)

Report generated on 2020-03-09

VEHICLE DETAILS

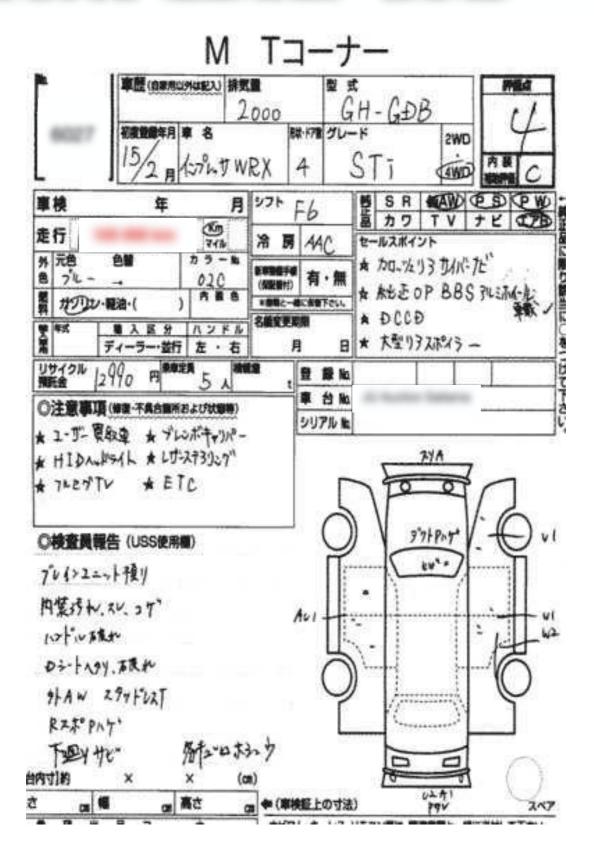
Inspector Report

Small scratches

Cigarette burned holes on the Carpet

Under the Bumper (A)

Rear bumper under (A)

Outside AW studless tires
