2010 TOYOTA LAND CRUISER AXG60 BLACK LEATHER

Report generated on 10-06-2020

VEHICLE DETAILS

CONDITION SHEET ENGLISH TRANSLATION

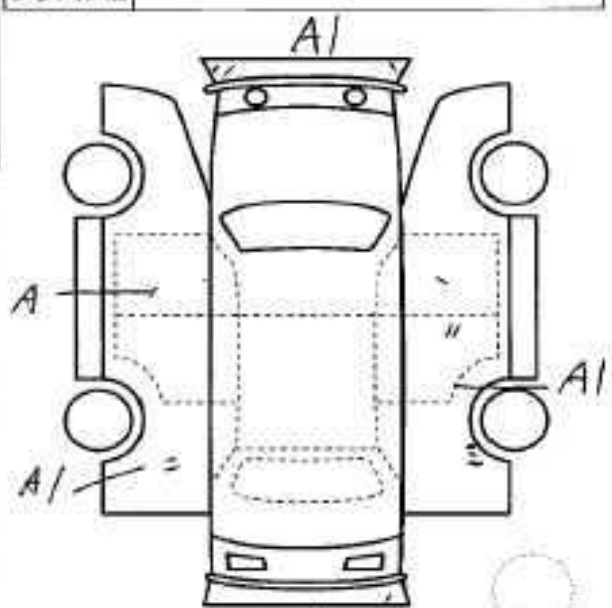
シート預り
Dシートスレ
下廻りナビ
各々ズレ

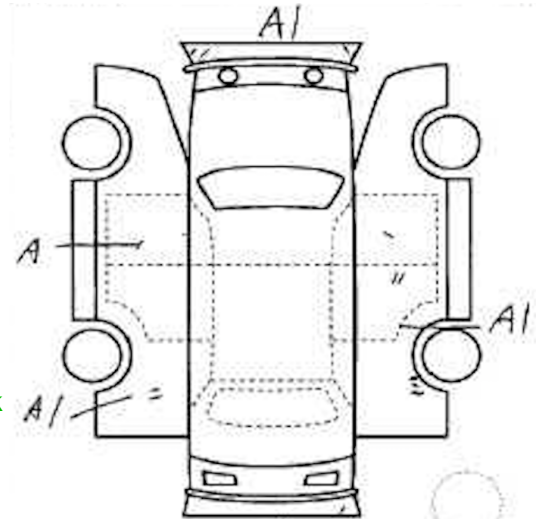
Seat small scrach

Interior dirt

Body small scrach
