1994 TOYOTA SUPRA RZ

Report generated on 2020-06-26

CONDITION SHEET ENGLISH TRANSLATION

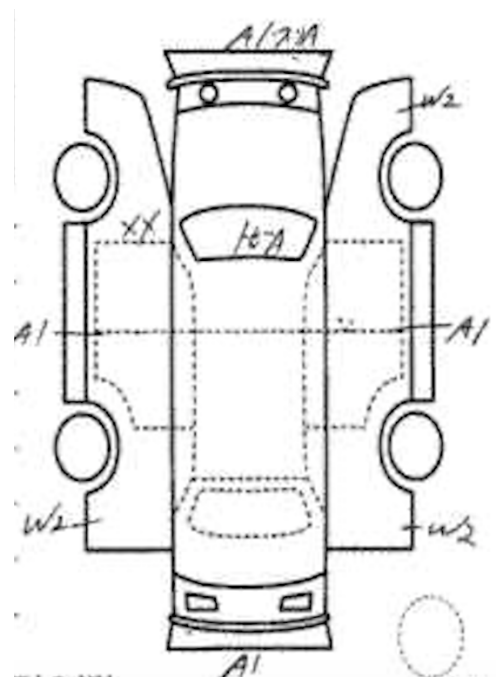
Left Fender Part Exchanged **XX**

Repair mark on front right Fender **W2**

Reat Left Quarter Panel repair mark **W2**

Reat Right Quarter Panel repair mark **W2**

Small scratches on Exterior

Front bumper scratches

Rear bumper scratches

Small crack on windscreen
