## 2013 TOYOTA PRIUS S (SAMPLE)

Report generated on 22-07-2020

## CONDITION SHEET & PHOTOS

Date : 2019-07-25 Source : LUM Kobe Lot No : 70703

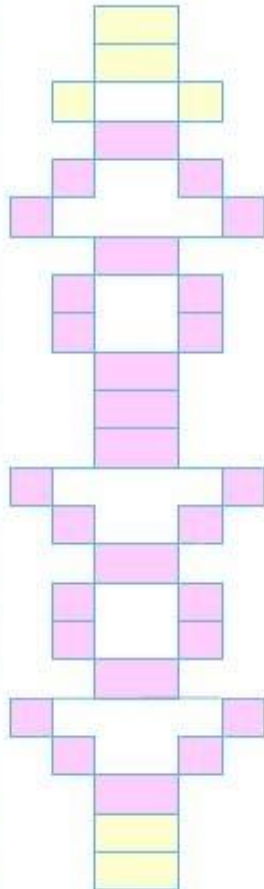
交換・修理・塗装跡以外のダメージ程度  
については損傷画像でご確認ください。

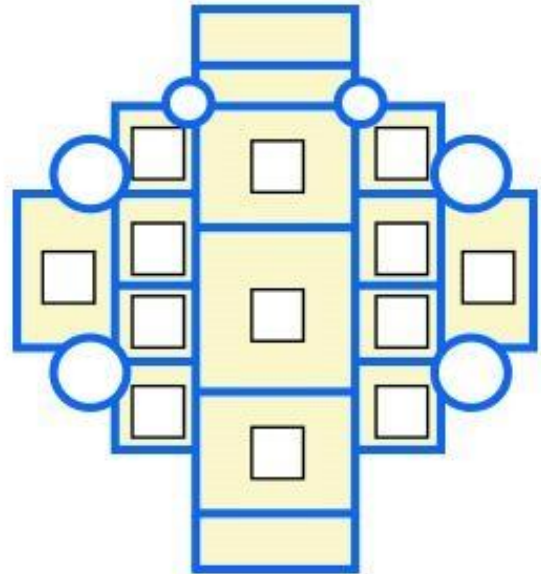
No problem found on the vehicle frame

Small scratches on exterior **A**

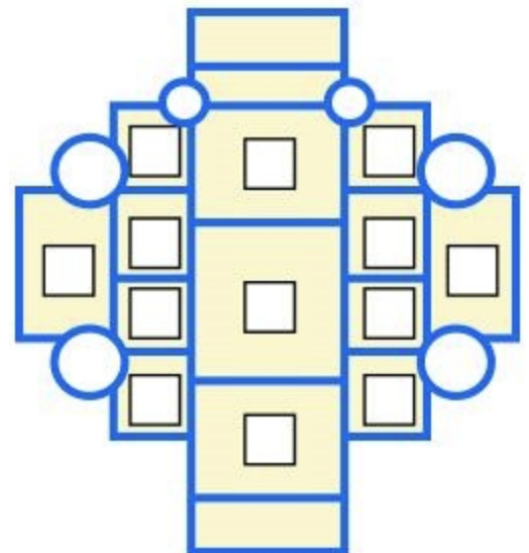
Small scratches on exterior **A**
