2013 VOLKSWAGEN GOLF TSI TREND LINE MEISTER EDITION BMT

Report generated on XX-XX-2020

CONDITION CHECK ENGLISH TRANSLATION

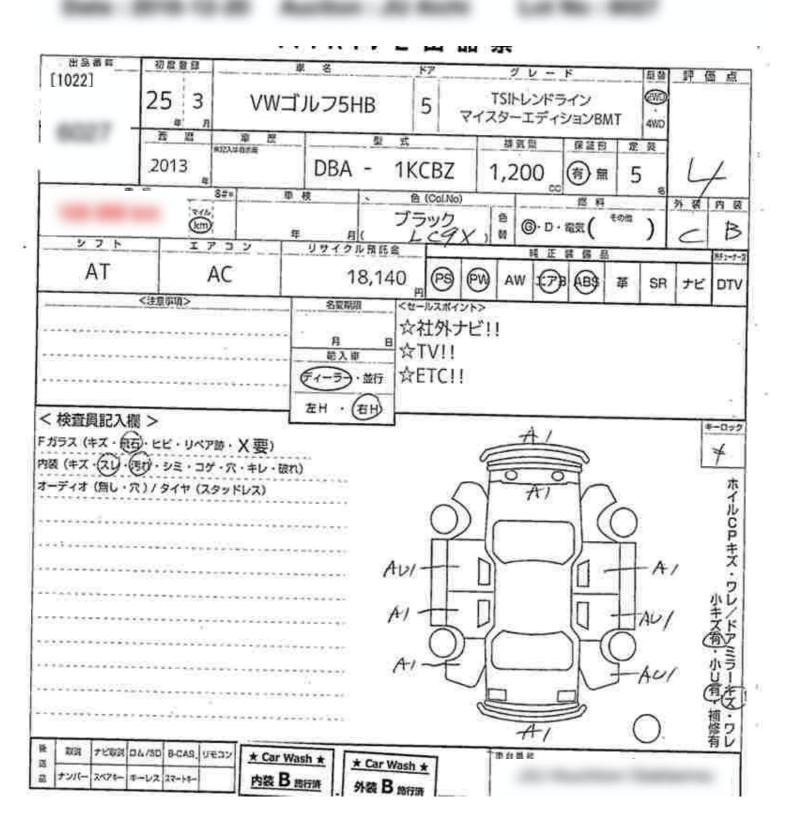
Small scraches on exterior A1 Front bumper small scratch Rear bumper small scratch
