**1994 TOYOTA CELICA GT-FOUR**

Report created by hand on 2021-07-05

CONDITION SHEET & PHOTOS

# CONDITION SHEET ENGLISH TRANSLATION

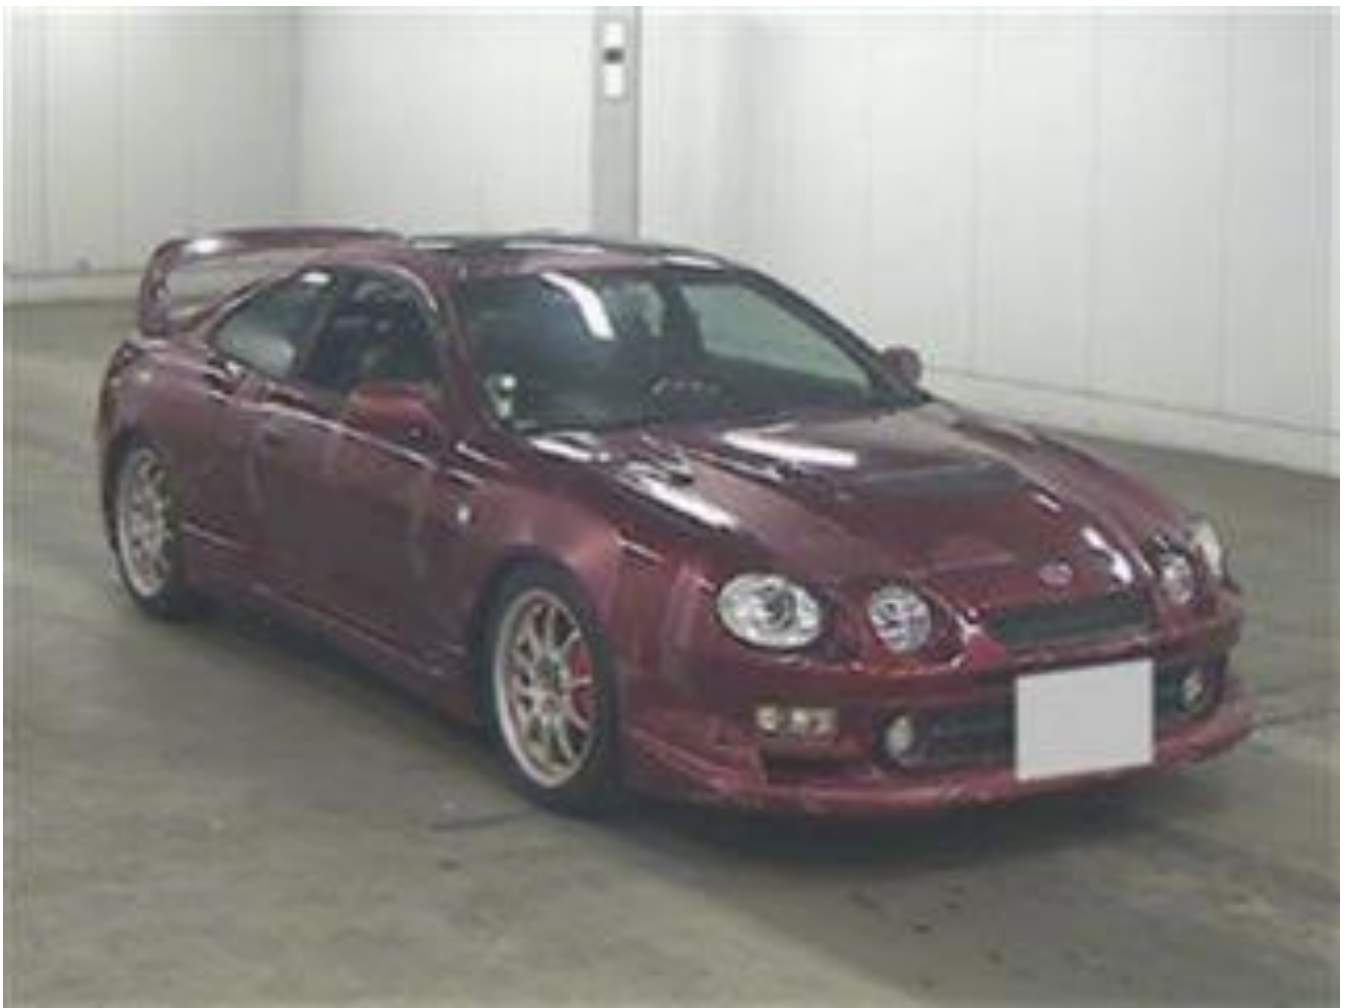
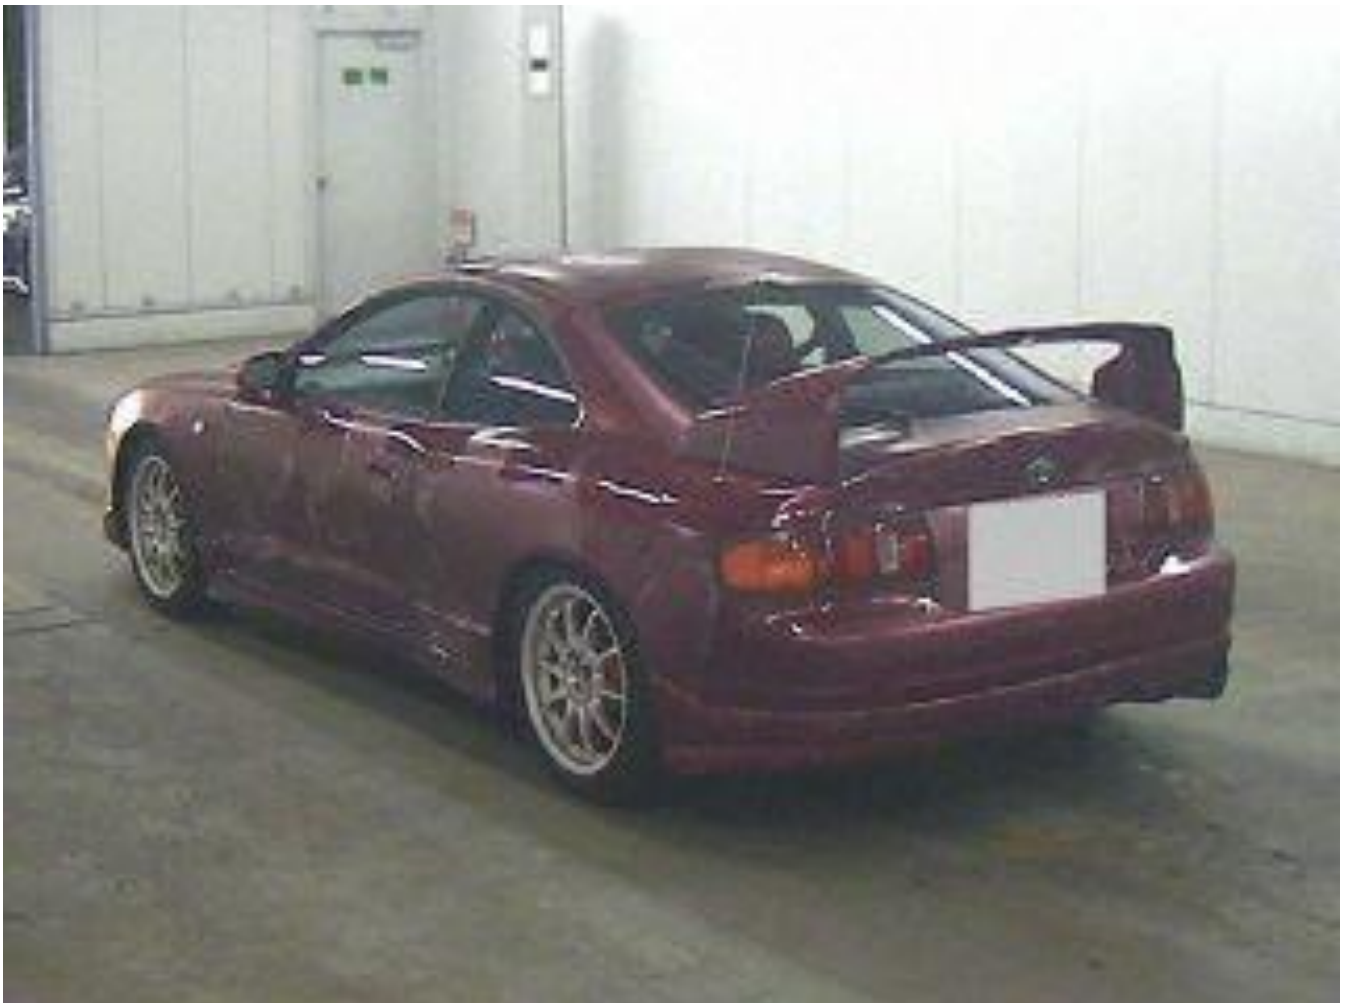
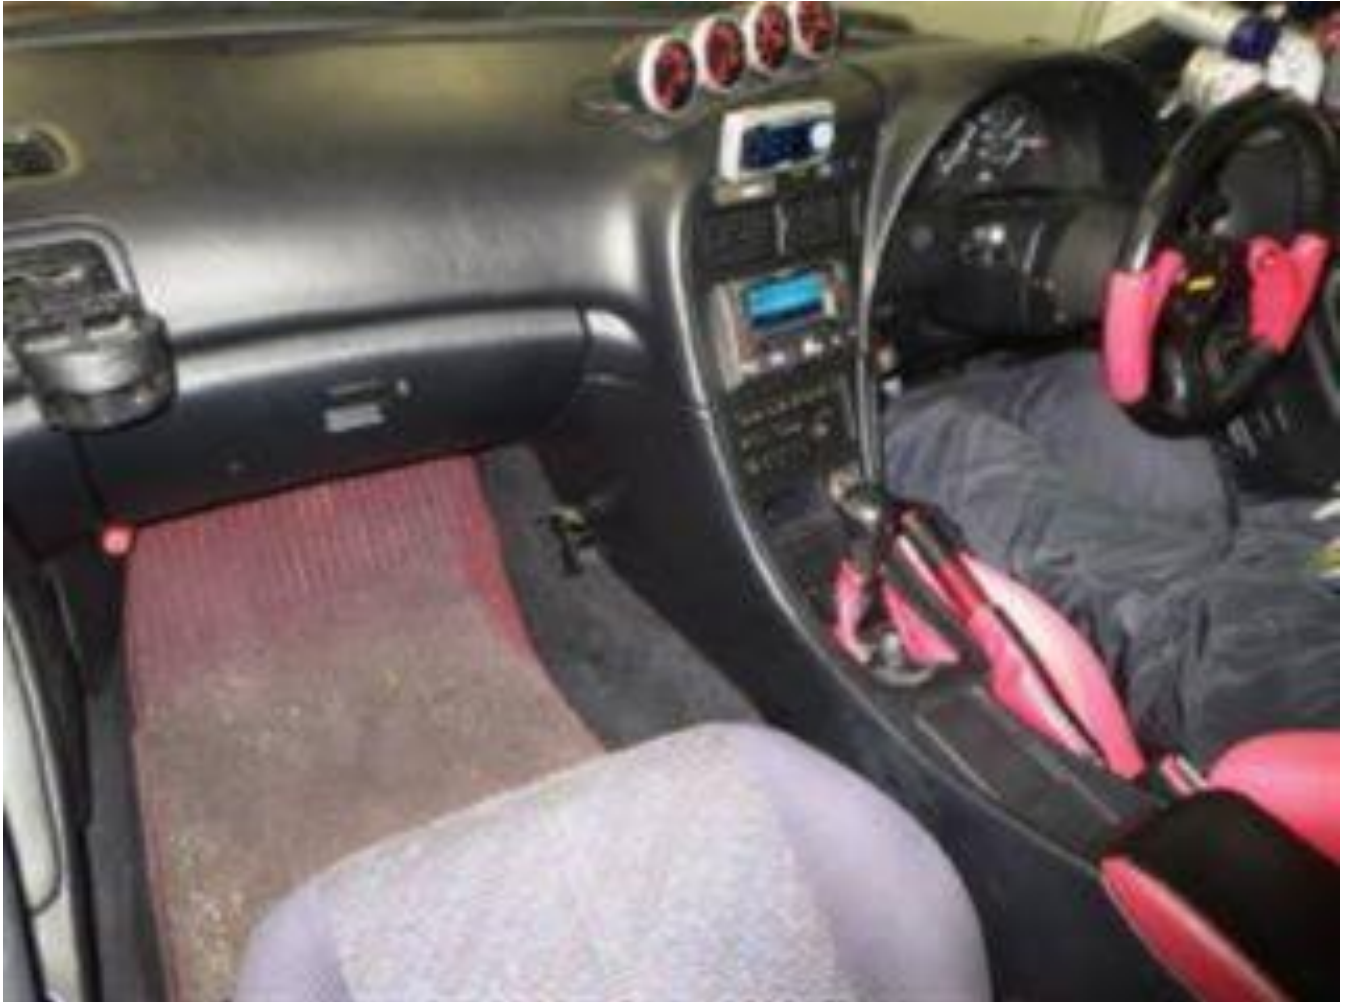
Left front inner panel edge, baffler -deformations  
 Some exterior scratches and dents  
 Hood, left front fender were replaced **XX**  
 Stripped door trim  
 Dirty cabin  
 Faded seats  
 Badly peeled paint on the body  
 Lack of wheel hubcaps  
 Non original air cleaner  
 Rear gate damper - not working  
 Overheat marks  
 Rust in radiator
