REPORT NO: BCNR33-XXXXXX

1995 NISSAN SKYLINE GT-R (SAMPLE)

Report generated on 2020-04-04

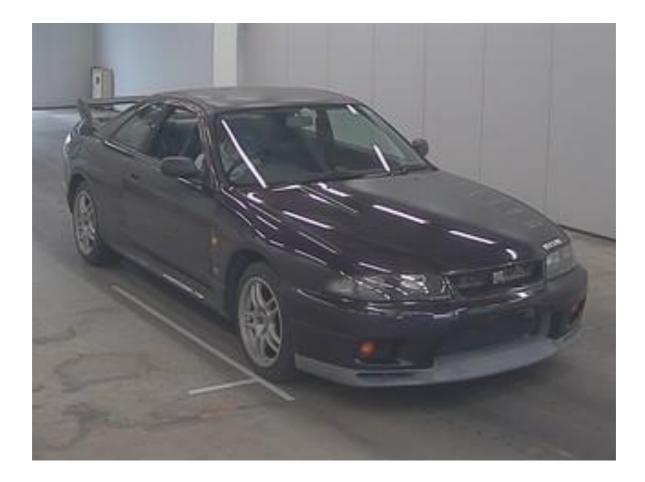
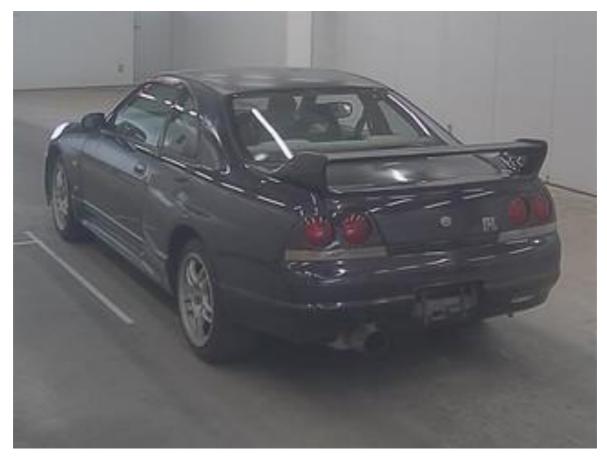
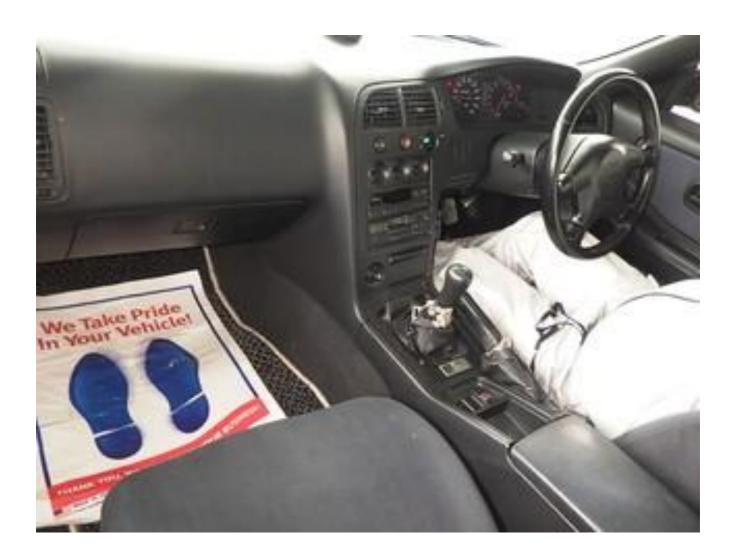
** Verified Photos

Hood repair mark W2

- Roof paint mark
- Right door replaced XX
- Right skirting replaced XX
- Fron right side repair mark W3
- Rear left side paint mark
- Scratches on the exterior A1
