1994 TOYOTA SUPRA RZ

Report generated on 2020-06-26

CONDITION SHEET ENGLISH TRANSLATION

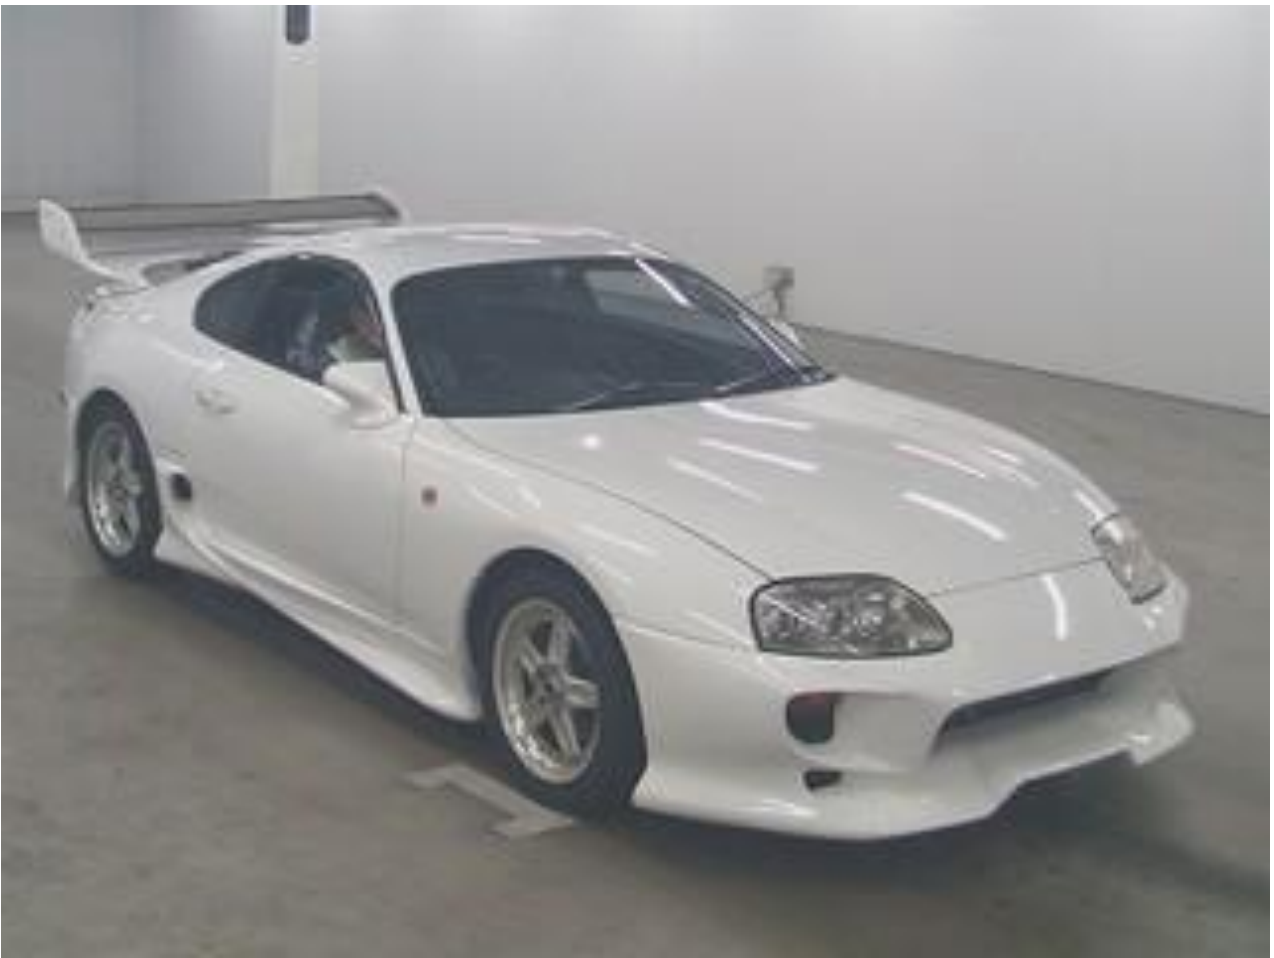
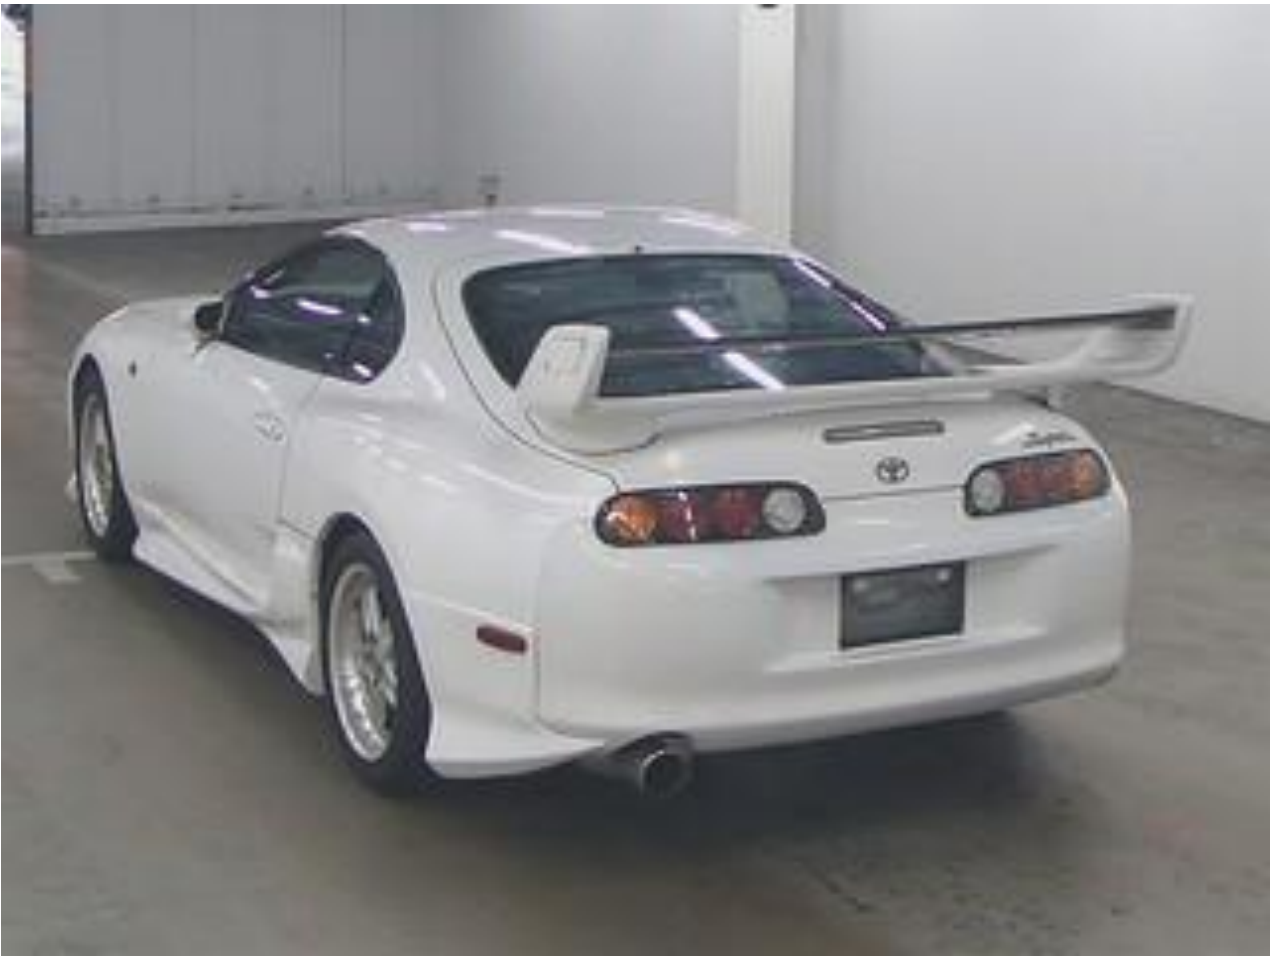
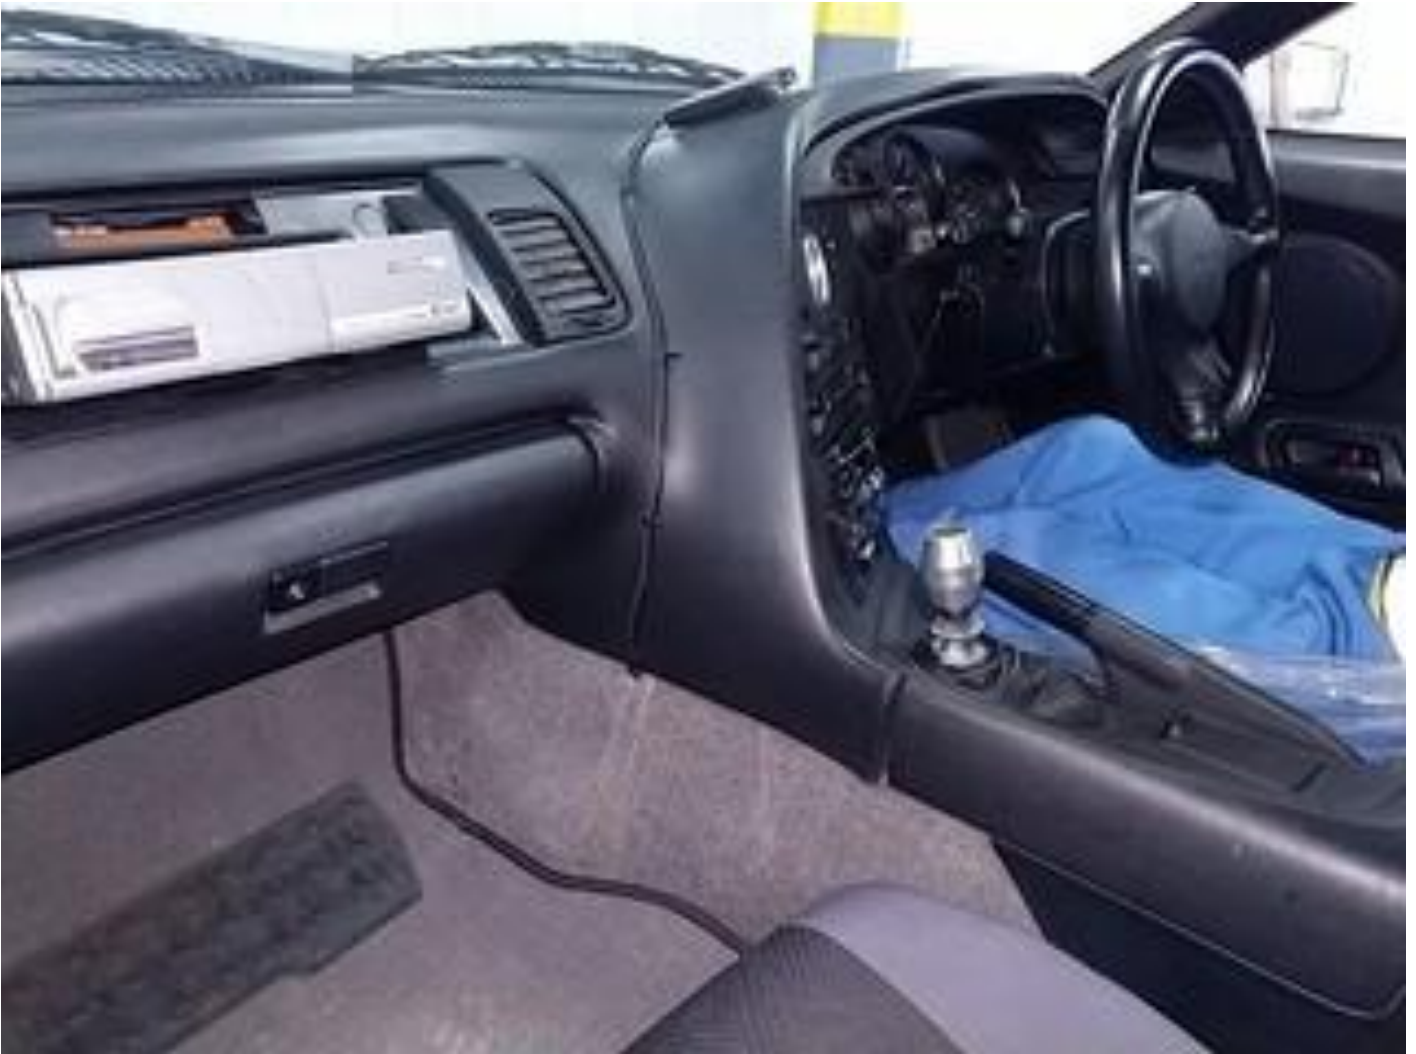
Repair mark on front right Fender **W2**

Reat Left Quarter Panel repair mark **W2**

Reat Right Quarter Panel repair mark **W2**

Small crack on windscreen
